# SEALING AROUND WELDED PIPEWORK ENTRY FOR CHEMICAL TANK

ID: 9850

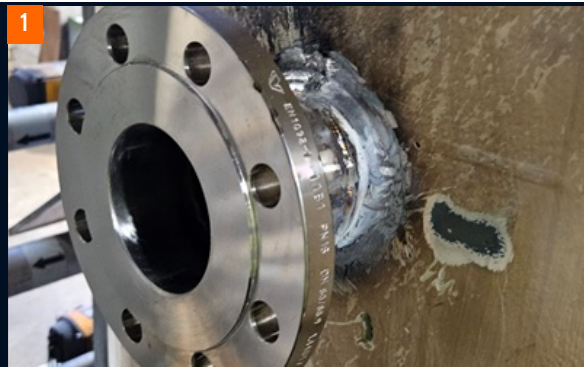
1. The new pipework is welded and in place
2. Masked edges and mechanical surface preparation
3. Grouted surfaces with Belzona 1161 to seal around the new weld
4. Finished result with two coats of Belzona 1391T

Mechanical surface preparation, Trowelling with Belzona 1161 on the new weld and transition, then 2 coats of Belzona 1391T
