# BELZONA SHAFT REPAIR ON COMMERCIAL MIXER IN FOOD PRODUCTION FACILITY

ID: 9851

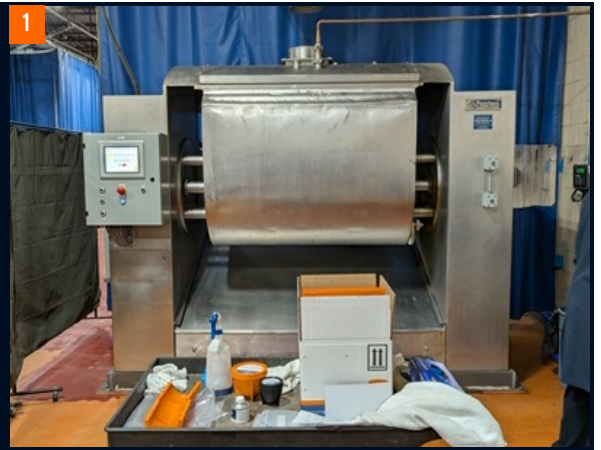
The Client, operating a Food Production facility in Mississauga, Ontario. Had a large scale, horizontal mixer experiencing advanced wear on several output shafts. Subsequently, the mechanical seals were unable to perform due to the damage, causing both product leakage and potential contamination. The equipment was a piece of legacy hardware that had previously been retrofitted and repaired using an unknown product.

1. Showcasing the piece of equipment
2. Completed surface prep of the damaged area
3. Repaired area using the Forming technique
4. Completed repair area
