# REPAIR OF HYDROELECTRIC POWER STATION SPILLWAYS

ID: 9852

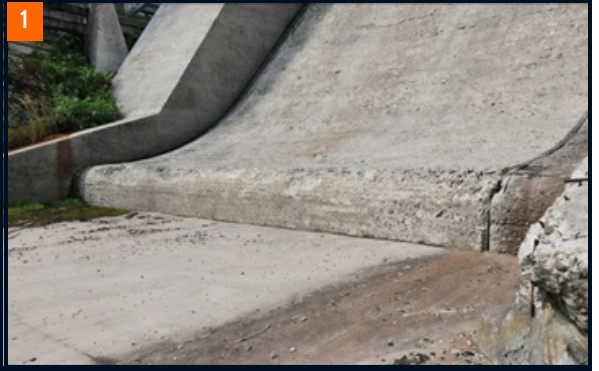
The problem was porous concrete that both erodes and draws moisture at certain times of the year leading to frost cracking. This has led to some corrosion also affecting the reinforcement. So it all accelerates with each passing season

1. The spillway shows what it looked like before we started work
2. Here the surface is grit blasted, and loose parts are identified and tapped away so we have a firm and good surface to continue the repair.
3. Once the surface has been blown clean, apply a coat of Belzona 4911 adhesion primer with anti-corrosion properties. Then overlay the existing surface with Belzona 4111.
4. Here is the finished result, the edge is coated with Belzona 4111 so no more frost cracking or erosion problems
