# BELZONA 5811 STOPS CORROSION IN WASTE TREATMENT SYSTEM

ID: 9855

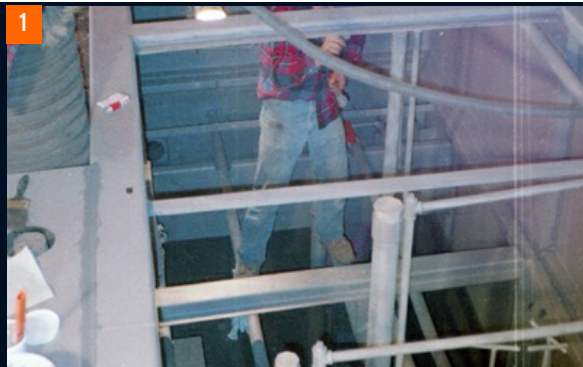
1. Blasting the unit
2. Weld seams coated with Belzona 1111 (Super Metal)
3. 1st coat of Belzona 5811 (Immersion Grade) Gray
4. 2nd coat of Belzona 5811 (Immersion Grade) Black

Grit blasting was the preferred surface prep method followed by flooding with Belzona 9111 (Cleaner/Degreaser). Belzona 1111 (Super Metal) was used to stripe the weld seams followed by two 10-mil coats of Belzona 5811 (Immersion Grade)
