# BELZONA SAVES CHOPPER PUMPS DESTINED FOR THE SCRAPYARD

ID: 9856

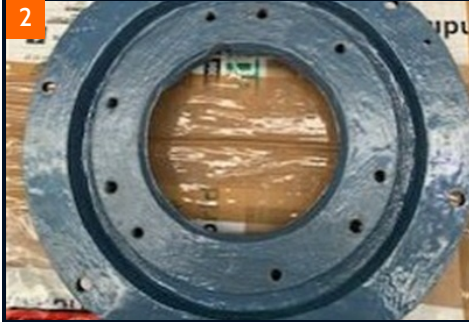
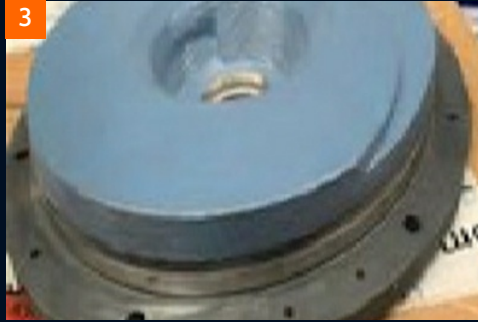
1. Wear plate being coated
2. Wear plate being coated
3. Wear plate being coated
4. After 6 months being in service

The Customer free issued new wear components consisting of Front wear plate, Back wear plate and Volute casing, Grit blasted new components to achieve correct surface profile in line with SA2.5 Applied Belzona 1321 Abrasive Resistant coating.

Gritblasted to SA Standard  
Coated with Belzona 1321

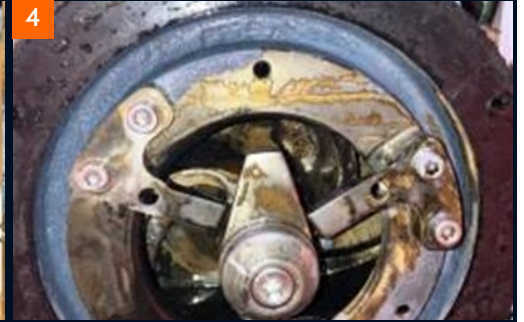
After the 6 month inspection the customer stated the following below  
The service and inspection were carried out last week with success. We have saved the parts in between servicing and they will last until the next service. Doubling the life of the parts!!!
