# BELZONA 4111 FOR REBUILDING STAIRS

ID: 9857

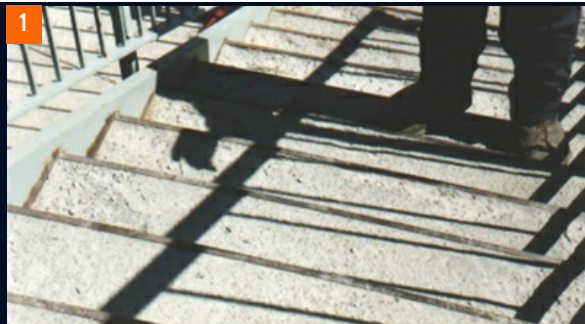
The concrete on these steps was completely worn posing a dangerous work environment

1. Picture of the problem area
2. Cleaned and applying Belzona 4911 (TX-Conditioner)
3. Belzona 4111 (Magma Quartz) being trowel applied
4. Finished!
