# BELZONA REPAIRS HOLED NOZZLE ON GLYCOL PLANT

ID: 986

Corroded and holed 3 inch diameter nozzle

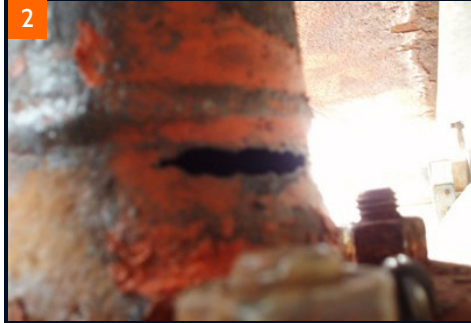
1. View of plant area
2. View of one of the two holes in the nozzle
3. View of the plates prior to bonding
4. View after the plate bond and wrap was completed

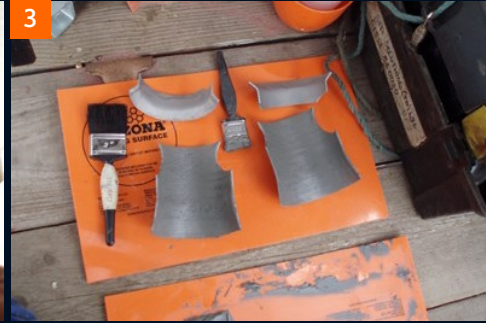
Corrosion had caused severe wastage of a nozzle which resulted in two holes breaking through.

Application was carried out in accordance with Belzona Know-How System Leflet VPF-11a. Plates were tailor made on site to completely encapsulate the nozzle. Once bonded, the whole nozzle was also wrapped.
