# BELZONA IMPROVES THE DURABILITY OF A BRAND NEW SCREW CONVEYOR LOADER TROUGH

ID: 9860

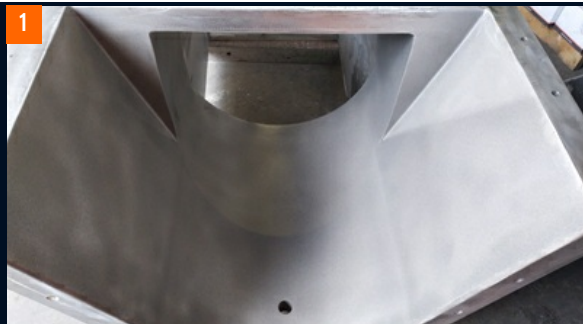
1. The new fabrication, following grit blasting to a profile 75 microns and a minimum of Swedish Standard SA2.5
2. "Wetting out" the blasted substrate using Belzona 1321 as the adhesive.
3. Applying the Belzona 9811 alumina tiles to a 600 micron coat of Belzona 1321, following wetting out.
4. Once the Belzona 1321 had cured, Belzona 1812 was used to "grout" the tiles and interfaces of the Belzona 9811 Alumina tiles, leaving a fully protected surface to the filler trough.

Grit blast to SA2.5 and a profile of 75 microns
