# BELZONA REPAIRS PRIOR COATING FAILURE AND CAVITATION ISSUES WITH TRANSDUCER

ID: 9861

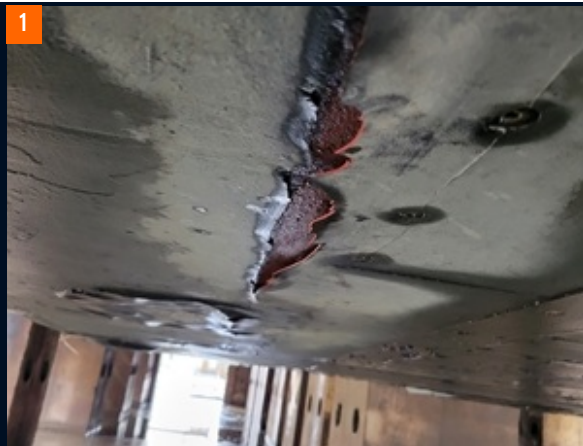
There were cavitation and Coating Failure issues on the underside of a Transducer of an Exploration Vessel, and they needed a quick turn-around to get back out to sea.

1. Failure or the previous coating due to cavitation and adhesion issues.
2. Support for padding used to protect the transducer and transmitters.
3. Application in progress.
4. Application completed.

The repair was carried out in accordance with the Belzona SOS-1, ensuring adherence to the highest industry standards. The process included:  
Surface Preparation: The damaged areas were cleaned and prepared by sanding and lite grinding to ensure maximum adhesion of the Belzona materials. This included removing any loose debris, contaminants, and preparing the surface for the composite.
