# WET PULP SCREW CONVEYOR SUFFERING FROM LOCALISED EROSION

ID: 9865

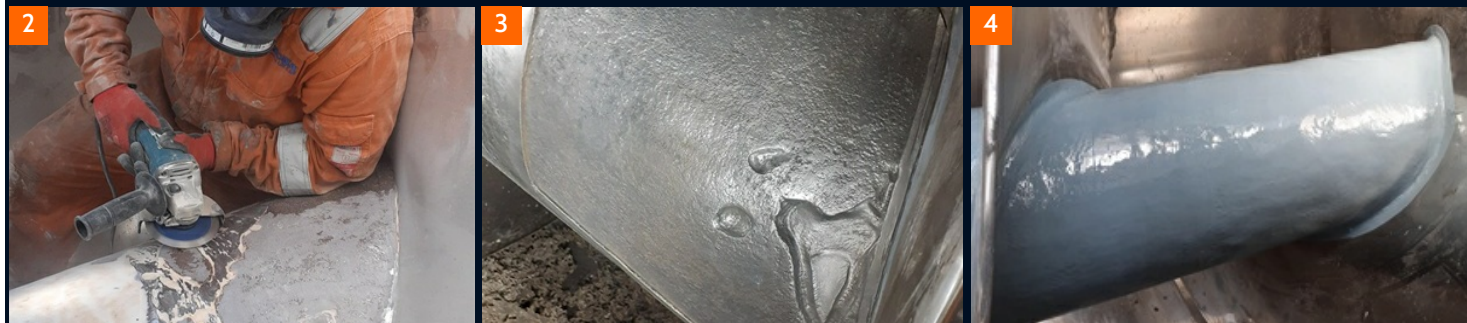
Customer has a Wet Pulp Screw Conveyor with localised areas of erosion and scoring. These defects were causing process issues and preventing the conveyor from operating at its optimum capacity

The three areas of concern were located on the shaft only, affecting three separate sections between the screw flights. The total repair area was estimated to be approximately 2m<sup>2</sup>.

1. Wet pulp screw conveyor was suffering from localised erosion and scoring
2. work commenced on in situ repair, cleaning the area with power tools
3. Cleaned areas exposed surface areas that required rebuilding with Belzona 1311
4. Finishing with two coats of 1391(T), Belzona solution

To limit disruption, the application areas were prepared using power tools only. Once prepared, the areas were thoroughly cleaned and rendered dust-free. Any sections showing loss of profile were rebuilt back to standard using Belzona 1311, a two-component repair composite. Following this, the full circumferential repair areas were reinforced using Belzona 1311 and Belzona 9341 Reinforcement Sheet, applied using a 50/50 overlap system and left to stabilise overnight.

On the following morning, the repaired areas were inspected and dressed back before receiving two coats of Belzona 1391T.
