# ACC FAN BLADE REQUIRED A LEADING EDGE PROTECTION SYSTEM

ID: 9867

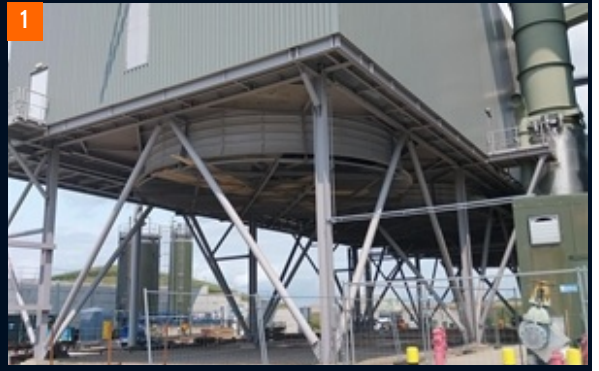
Customer at an energy from waste plant had air cooled condenser (ACC) fan blades that were suffering from wear and tear due to abrasion.

1. Six 5m length blades were exposed to abrasion and wear and tear
2. The application could be completed without dismantling the blades from the motor
3. Belzona 5711 and Belzona 5721 was chosen to protect the edges of the blades and provide them with an extended life
4. Quick curing time, ensured that the ACC fan could be back in operation quickly
