# PETROCHEMICALS HOT SULFUR TANK

ID: 9874

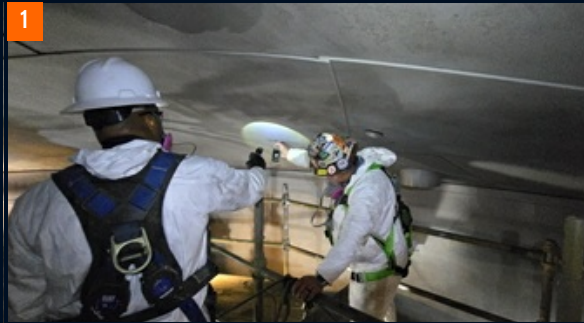
1. Inspector inspecting the tank for blast ISO 8501-1 Sa 2½ very thorough blast cleaning American Standard near white finish SSPC SP 10 Swedish Standard Sa 2½ SIS 05 5900 d) After blasting, metal surfaces should be coated before any oxidation
2. Belzona 1593 outside the tank ready to be installed
3. View from the top side of the tank, looking down.
4. Looking across the tank at the scaffolding and the Belzona coating
