# BELZONA REPAIRS HEAVY TRAFFIC CONCRETE FLOOR

ID: 9878

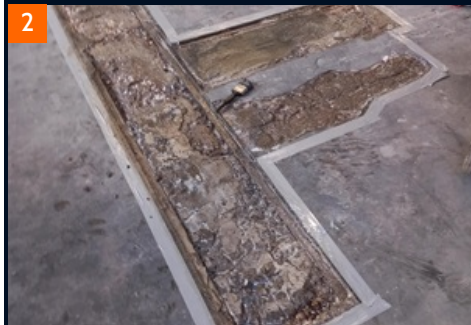
An area just inside the main roller door entrance, to a busy engineering works, experienced heavy traffic from forklifts, delivery vans and lorries. Over a period of time, the concrete slab gave up and started to disintegrate under the pressure of the traffic

1. Part of the main repair, a previous application failed after only 6 weeks. This was their fourth attempt at repairing this floor area
2. Old, loose concrete and failed repair, no further excavation required. Area coated with Belzona 4911 (TX Conditioner)
3. Application of Belzona 4131 completed by the company's own staff, under supervision of the Belzona Area Sales Engineer
4. Shown here, in every day use, some 6 months on

Remove loose and friable

Vacuum area

Mask up border lines

Mix and apply Belzona 4911 (TX Conditioner) to target areas

Mix and apply Belzona 4131 (Magma-Screed) with a gloved hand and compress to finish using a finishing trowel
