# BELZONA SOLUTION DIFFICULT RACKING ISSUE

ID: 9879

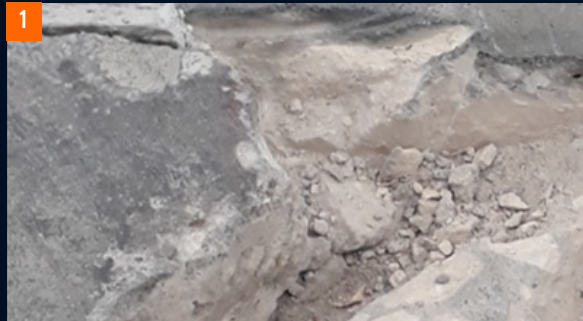
New racking was required due to expansion, but the area assigned was showing issues and the engineers were worried that the installation of the racking would not be approved by inspectors under the Provision and Use of Work Equipment Regulations 1998 (PUWER)  
It was decided to ask the local Belzona engineer for a spec on a solution to install a stronger pad for the uneven target areas

1. Floor failed where racking was due to be placed
2. Opening up into the area of repair
3. This shows the 500mm x 500mm pad constructed from Belzona 4111
4. A further view of the new pad

The area was marked out and a frame was set to level. This frame was coated with Belzona 9411 release agent  
The area was made rough, using cordless grinders with flap wheels and the area was vacuumed and cleaned  
Belzona 4911 TX Conditioner was applied to the area as per the Belzona 4911 Instructions for Use  
Following this, the Belzona 4111 resins were mixed in a receptacle. The Belzona 4111 aggregate was added and mixed well  
This was applied inside the frame and compressed/levelled using a finishing trowel.  
Any unfinished external areas were also repaired using the system as above to leave a solid, level pad for the bolting of the racking to take place
