# HISTORICAL MARKER REPAIR WITH BELZONA 7311

ID: 9889

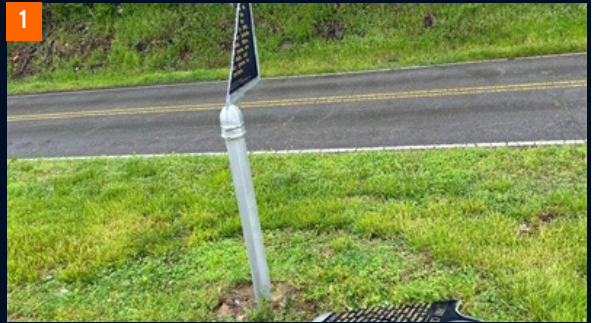
This historical sign for a local graveyard dating back to the 1800's was struck by a vehicle that ran off the road. The vehicle struck the sign causing it to break into two separate pieces.

1. The signage was broken.
2. Belzona 7311 was used to repair the damage.
3. Both halves of the signage being clamped together for improved adhesion.
4. Finished application.
