# BELZONA SOLUTIONS FOR REBUILDING & COATING LUBE COOLER/END COVER

ID: 9891

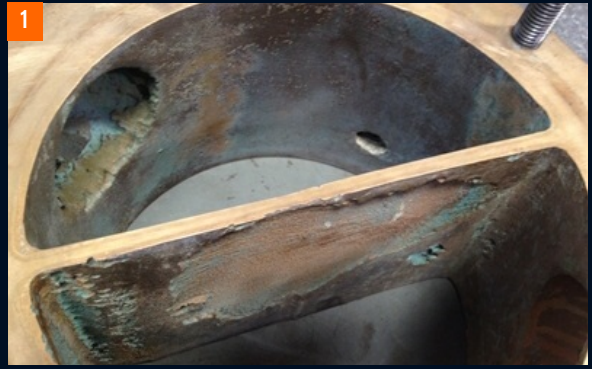
One of our offshore clients reported a case of corrosion affecting their heat exchanger (HEX) equipment. The root cause was identified as prolonged exposure to the highly humid and saline atmosphere typical of offshore environments. Such conditions significantly accelerate material degradation, leading to concerns regarding the structural integrity, safety, and long-term operational reliability of the equipment.

1. Degraded heat exchanger due to corrosion.
2. Surface preparation was done through grit blasting to SA 2.5 standard.
3. After cleaning the surface with Belzona 9111 (Cleaner Degreaser), Belzona 1311 (Ceramic R-Metal) was used to rebuild the damaged areas.
4. The equipment was subsequently coated with two layers of Belzona 1391 (Ceramic HT) to ensure long-term protection.
