# BELZONA 1321 PROVIDES NEW LIFE TO HEAT EXCHANGER TUBE SHEET

ID: 9892

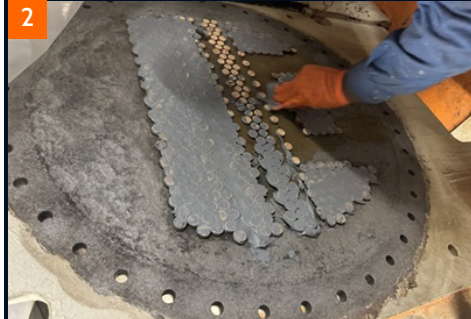
This 20 year old tube sheet was facing significant wear and corrosion following many years in service. Our customer was looking to restore the existing tube sheet to protect it and keep it running in the future.

1. Before / Unrestored
2. In Repair Process: Following Sandblasting, corks are placed and Belzona 1111 is used to rebuild low areas.
3. After (2) coats of Belzona 1321, the corks are then drilled out and the tubes are touched up.
4. Final product, Belzona 1321 applied and good to go.
