# BELZONA 2111 RESTORES WATER VALVE WEAKENED EXPANSION JOINT AT POWER PLANT

ID: 9894

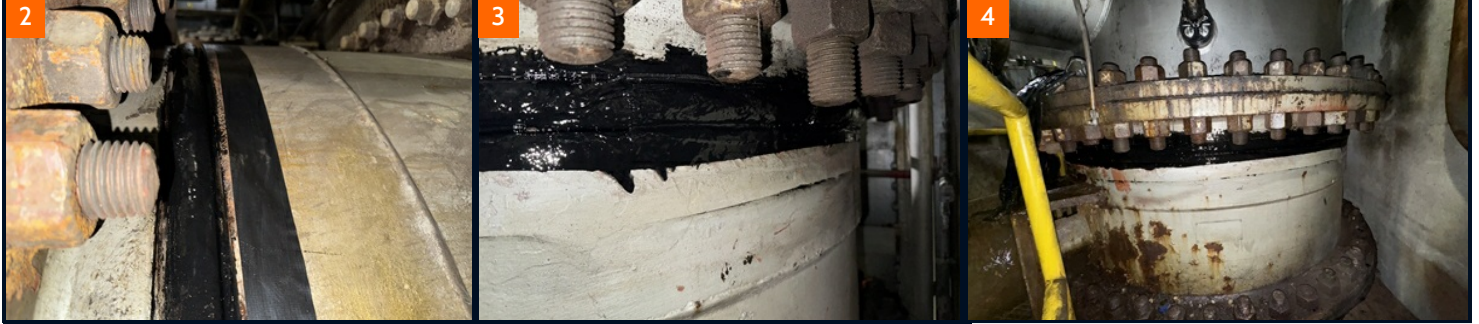
1. Completion Photo 1: Access Into the Valve provided a chance to apply Belzona 2911, 2111 directly on the inside of where the leak had occurred. These products applied after preparing the steel+rubber.
2. Completion Photo 2: Exterior View of Belzona 2111 applied to the Entirety of the Expansion Joint
3. Completion Photo 3: Close Up of Exterior Repair
4. Completion Photo 4: Full View of Exterior Repair

An MBX grinder and roughing brush were used to prepare the expansion joint and surrounding steel that needed to be addressed. Belzona 2911 conditioner and Belzona 2111 were mixed and applied with a brush and applicator.
