# COOLING UNIT IN A HOSPITAL WATER BOX

ID: 9895

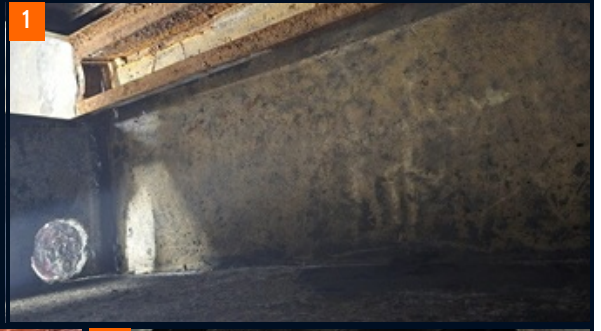
The pan was suffering for corrosion and pin holes that was leaking water out of the pin holes and running into a operating room

1. Inside look cooling unit pan before first coat
2. Outside look cooling unit pan before first coat
3. First coat of Belzona 5811 red
4. Second coat of Belzona 5811 black

We could not use any blasting equipment, so the pan was prepped by a wire cup on a grinder.  
no specialized equipment was needed.
