# FLOATING ROOF REPAIR.

ID: 9896

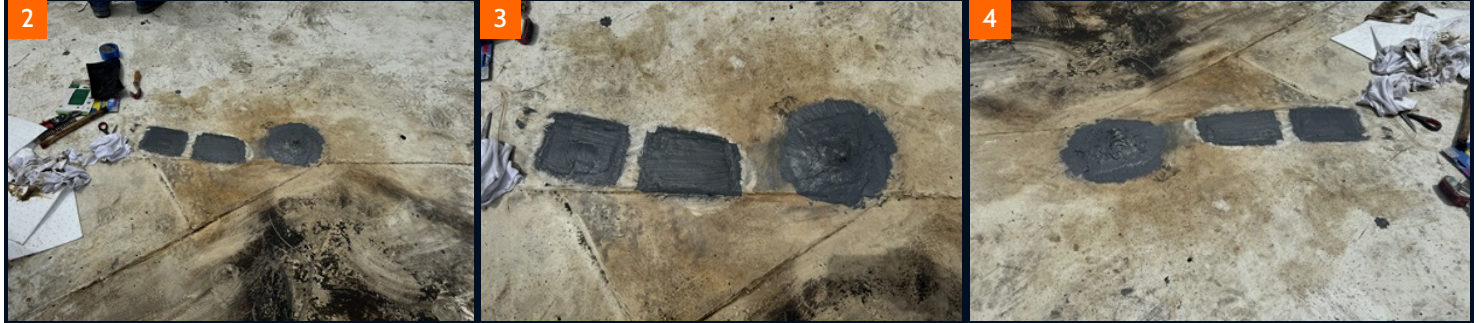
The floating roof developed a couple of corrosion holes on the plates.

1. Belzona 1212 Tank patches view 1.
2. Belzona 1212 Tank patches view 2
3. Belzona 1212 Tank patches view 3
4. Belzona 1212 Tank patches view 4

The area was prepped as best as possible by a hand metal brush, A Belzona 9611 emergency product was used to temporarily plug the hole. After cured a kit with a mesh and Belzona 1212 was used to complete the repair.
