# HI CHEM PUMP FEET PROTECTION

ID: 9897

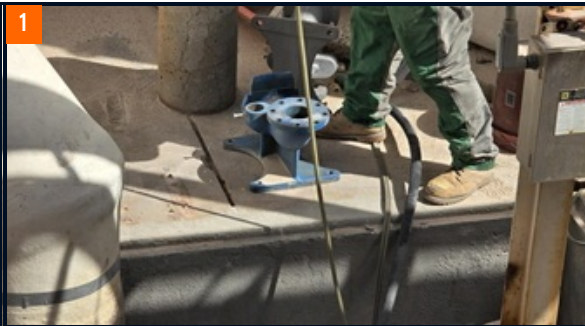
1. Pump pedestals being blasted
2. Pump pedestals first coat with Belzona 4311
3. Pump pedestals Close up first coat
4. Pump pedestals second coat
