# BELZONA REPAIRS TO LARGE RUBBER LINED VALVE

78-inch butterfly valve from cooling water system.

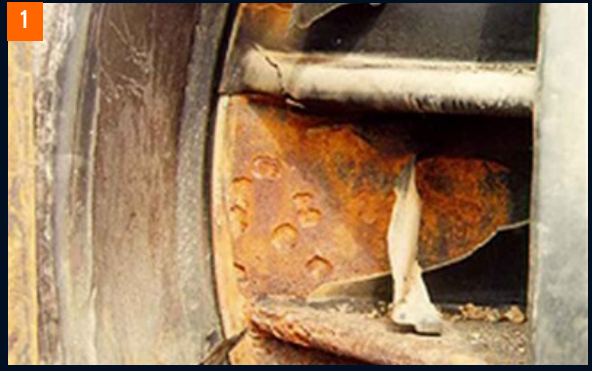
Premature failure of vulcanised rubber lining allowed severe erosion-corrosion of underlying steel after just three months in service.

1. Condition of the valve after just three months in service
2. Close-up of Belzona application showing encapsulation of bolts on valve disc
3. Completed application.
