# BELZONA PREVENTS LEAKAGE IN A BALL MILL BEARING JOURNAL

ID: 990

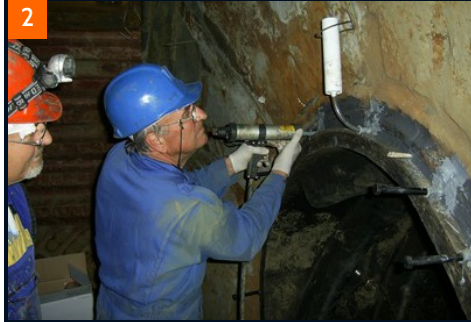
Inside view of the Ball Mill Injection ports were created axial in the front of the insert with Belzona 1221 and then Belzona 1321 was injected to complete sealing of the annular gap Injection of Belzona 1311 as irregular shimming along the insert length The applied Belzona materials still in perfect condition after 9 month and more than 5,500 working hours of the equipment
