# BELZONA SHAFT REPAIR

ID: 9900

## PROBLEM

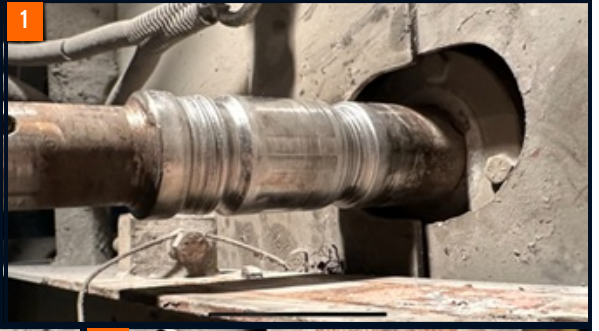
Bearing failure caused this shaft to wear in multiple places over 1/2 inch deep.

1. Worn Shaft from bearing failure
2. Close up, getting ready to prepare the surface with a MBX Bristle Blaster.
3. Applying Belzona 1111 using a machined former to match the I.D. of the shaft.
4. Final result after two hours under heat to force cure we removed the former and used emory cloth to finish the surface to a smooth surface.
