# BELZONA REPAIRS SUCTION BELL

ID: 9901

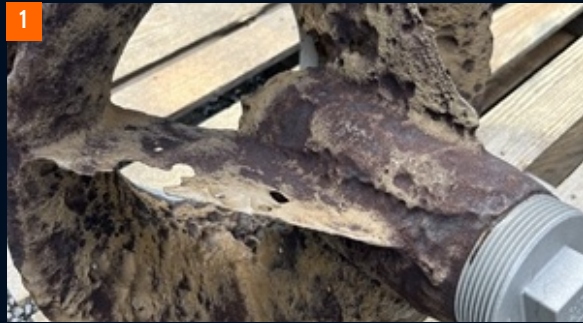
This suction bell has been in brackish water for over ten years and had not been taken out for service. They couldn't get a new suction bell in less than six months and the needed to be back up and running in two weeks.

1. Removing salts was a major priority in the first step of this repair.
2. Making repairs using Belzona 1111
3. Here we are showing you a technique we use in the shop to fill voids and using Belzona 1111
4. Finally we applied two coats of Belzona 1331 for a perfect finish.

We washed the suction bell with Salt-Away to remove the salts absorbed in the metal to achieve a 20pm or less. Once that was achieved we rebuilt and skimmed all pitted areas with Belzona 1111. Then we applied two coats of Belzona 1331.
