# PERMANENT LEAK REPAIR ON AGING LEAD AND OAKUM PIPE JOINT

ID: 9902

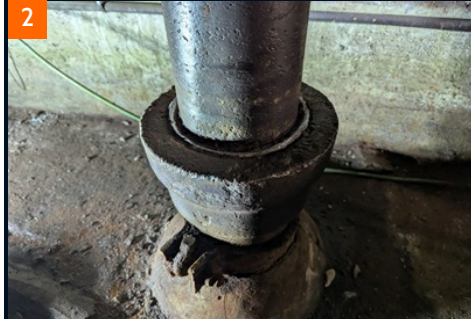
During the refurbishment of an old piping system within a commercial building, the customer discovered an active leak at a lead and oakum joint. These joints, common in older plumbing systems, had degraded over time, compromising the seal and allowing water to escape.

1. Leak through the hydraulic cement
2. Hydraulic cement removed and pipe cleaned with power tools to bare metal
3. Belzona 4141 to smooth out transition area
4. Full system wrapped and seal with Belzona SWII

The failed hydraulic cement was first removed, and the area was cleaned and roughened using power tools to eliminate rust and create a suitable surface profile for bonding. Once the substrate was properly prepared, Belzona 4141 was applied to rebuild and level the surface around the joint. This created a solid and uniform base for the application of the Belzona SuperWrap II system, which was installed using three layers of reinforcing wrap to fully seal and strengthen the joint.
