# STEAM VALVE RAISED FLANGE FACE REBUILD

ID: 9903

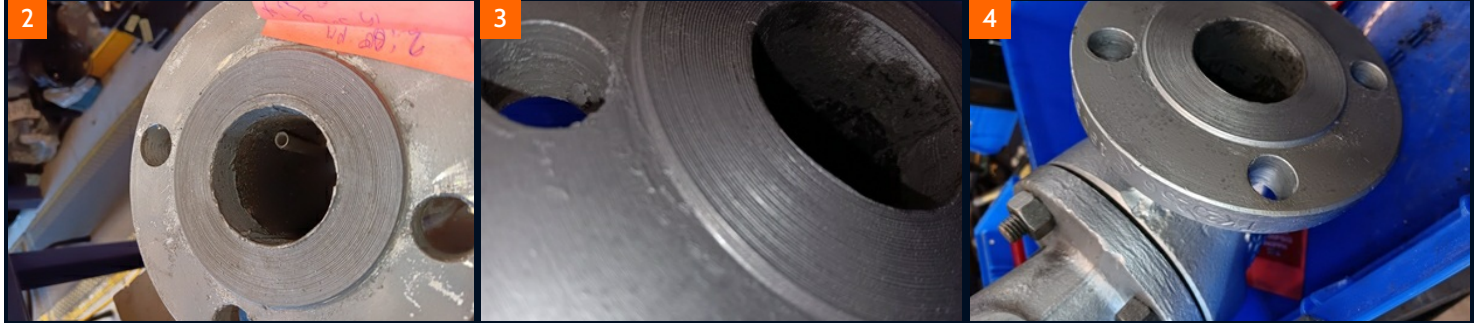
Raised flange face was showing signs of corrosion and was leaking past the gasket.

1. Flange face ready for preparation
2. Flange face rebuilt using Belzona 1511, 9411 with customer supplied former.
3. Flange face 1511 rebuild cured and ready for clean up
4. Rebuilt raised flange face complete and ready for installation and back into service.

The customer again decided to use a Belzona product for the rebuilding of the flange face for this was a cost saving to the companies customer instead of purchasing a new valve.

Tooling used cabinet blaster, pencil grinder, machining files flat and round and also the Belzona product mixing tooling
