# REPAIR DEMO TO FERRIC CHLORIDE PIPE

ID: 9906

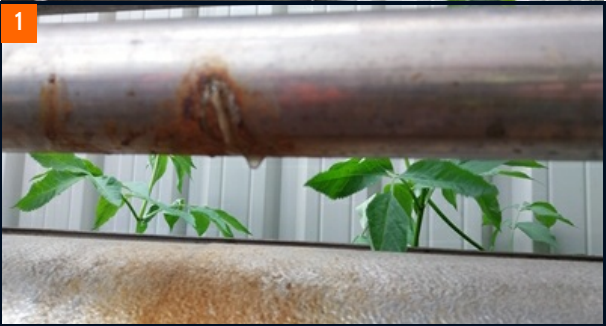
A pipe run of some 20m has numerous leaks. The engineers are looking for a solution by repairing the pipe, rather than replacing it. A replacement will be carried out at some point, but the repair is a better option for them at this time

1. Showing one of many leaks to the main Ferric pipe range
2. A general view of one leg of the pipe range
3. A repair effected by Belzona 1212 and Belzona 9341
4. Demo repair complete
