# BELZONA REBUILDS FLANGE FACES

ID: 9907

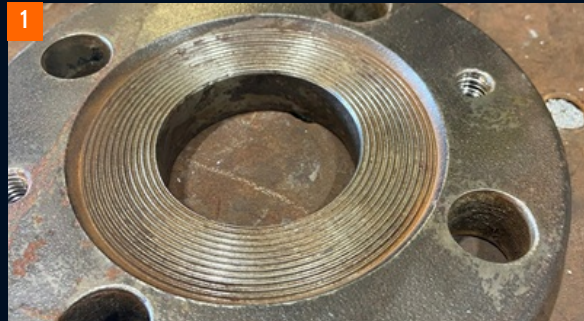
Client has numerous flanges that are corroded. They are replacing the flanges with new and want to coat the new ones to protect from corrosion and add life to their new assets. The cost and turnaround time to apply Belzona on the flanges was a great choice.

1. Close up on the flange before application.
2. Close up picture on the flange after Belzona 1111 is applied and cured.
3. Closeup picture on the flange after Belzona 1111 is applied and cured.
4. A number of flanges all rebuilt with Belzona 1111.

1. Power tool prep was completed using a grinder and cutting disk.
2. Belzona 9411 was used to apply on the fabricated former as a release agent.
3. Belzona 1111 was mixed and applied by brush to build up a ~.25" thick layer of product.
4. The former was applied and compressed the product. Once cured, the former was removed. The product was smooth and had a gramophone finish.
