# BELZONA SEALS CRACKS IN CONCRETE SUMP

ID: 9908

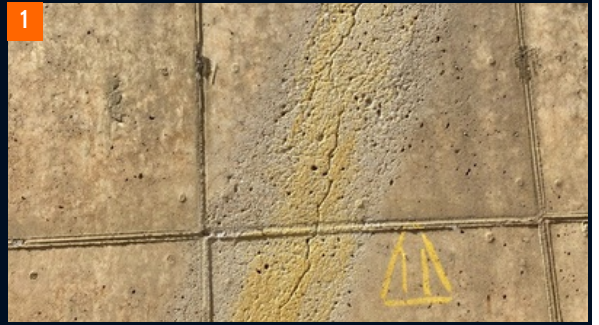
Customer has a large concrete sump that they dump chemicals and waste into. The concrete has cracked over time. They were looking for a repair method to seal the cracks to prevent liquid from inside going out, and vice versa. They previously repaired cracks using Belzona system and it held well for many years. There were additional areas that had not received Belzona that needed to be addressed. After an inspection, the report showed a few cracks that were greater than 1/8" wide and needed repair.

1. Crack in concrete along the wall of sump.
2. Close up photo of a defect in the sump wall.
3. Belzona 5815 and 9371 crack repair on the application area.
4. Floor to wall joint crack repair in grey, and existing previous Belzona crack repair in black still in good condition.

1. Power tool prep with grinders to vee out the cracks and prepare the concrete surface.
2. Apply Belzona 4911 conditioner
3. Apply Belzona 4111 to pit fill/rebuild lost concrete
4. Apply Belzona 5815 and 9371 to patch over the cracks

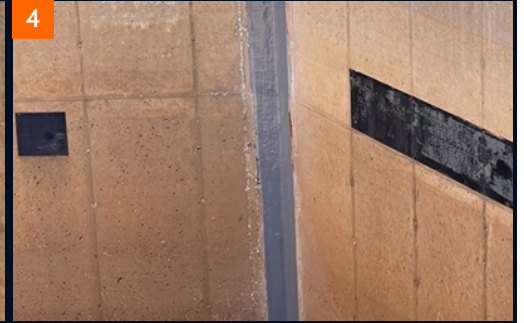
Customer needed a quick cost-effective solution to repair the cracks in concrete to add life to the sump. A previous Belzona repair was done 7 years ago and was still holding well, so they choose to use Belzona again in the repair areas.
