# BELZONA PROTECTS CHILLER AT A LARGE COMMERCIAL BUILDING

ID: 9909

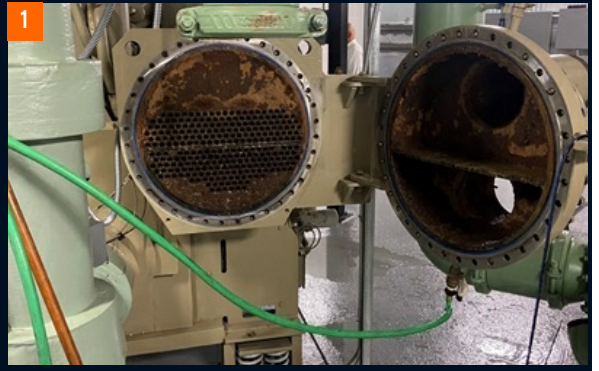
Client has 4 chillers to create air conditioning for their roughly 50 story building in downtown Houston. The building was built within the last 10 years, and has seen heavy corrosion/erosion on the tube sheet from the city water. When they complete their annual maintenance checks they have seen it get worse each year. They have tried different water treatment options but have not had success in limiting corrosion to metal on tube sheet, water box, and end covers. The onsite engineering team championed using Belzona to the building developer to provide a long-term corrosion protection solution.

1. Chiller current condition one side
2. Chiller current condition opposite side
3. Chiller completed application one side
4. Chiller completed application

1. Chiller was opened, drained, and dried with fans.
2. Containments were built with sheets of poly around both ends, making it air tight containment.
3. Tubes were corked.
4. Abrasive blasting was completed to achieve SSPC SP10 profile on the application area.
5. Belzona 1121 was applied to pit fill and rebuild lost metal where needed.
6. Belzona 1321 was applied in a two-coat system, grey first then blue topcoat.
7. Product allowed to cure and put back in service.
