# BELZONA PROTECTS SULFURIC ACID CONTAINMENT

ID: 9910

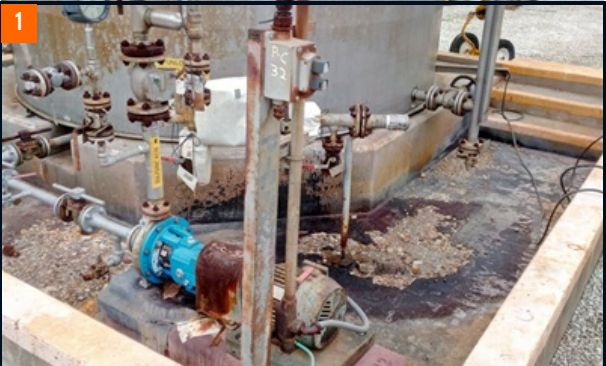
Client has a concrete sulfuric acid containment near a cooling tower. The concrete has damage from spills / leaks of the 98% sulfuric acid into the non coated concrete and from always being wet in TX humidity & nearby cooling tower mist. The acid and moisture have caused cracks & spalling in the concrete over time. The customer wanted a long term solution to protect the concrete.

- 1. Acid containment with damage in concrete before application
- 2. Belzona 4311 applied into containment
- 3. Close up on coating with non skid aggregate
- 4. About 1.5 years after install we completed a visual inspection of the coating and it was still in good condition.

- 1. A containment was built around the concrete containment.
- 2. The concrete was vapor blasted to roughen the concrete and create an optimal profile to bond to.
- 3. Belzona 4124 was used to rebuild lost concrete on the containment floor in the damaged areas.
- 4. First coat of Belzona 5811 was applied with nonskid to create a non-slip surface.
- 5. Belzona 4311 was applied as the top coat for long term protection against chemical attack.
- 6. Safety yellow paint was applied around perimeter on top of the dike wall

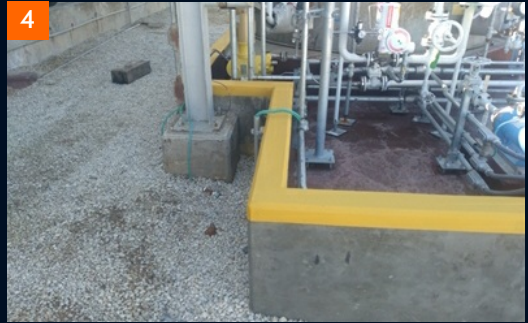
At the 1.5 year follow up inspection the coating was in excellent condition. The area showed no spalling, cracking, or delamination of coating. The customer is happy. If a facility has a spill of acid into ground soil it can cause extreme fines and shutdown of the facility. This Belzona repair helps protect from that happening.
