# DRIVE ROLLER GETS BELZONA GRIP SYSTEM

ID: 992

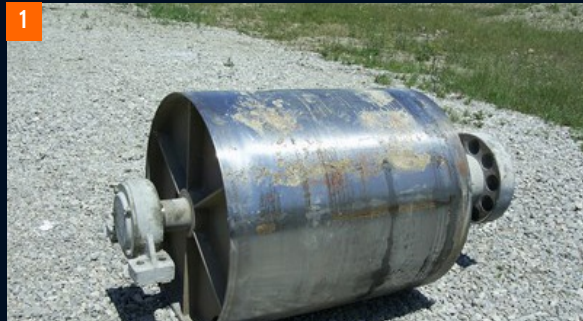
The drive roller had no lagging and was exposed to the weather conditions causing loss of grip and slippage.

1. Roller prior to application
2. Surface preparation by blasting
3. Chevron pattern was created
4. Completed application

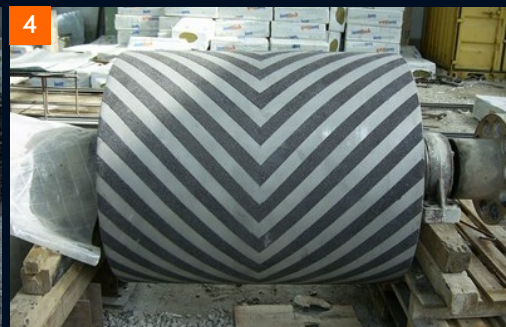
Belzona solution was half the cost and faster to apply than conventional hot vulcanization. The roll was prepared and the system applied without leaving the facility. At the end of 2007, the system is still in perfect condition and the client is considering application to another unit.
