# BELZONA REPAIRS COMMUNITY CHANGING ROOM CONTAINER

ID: 9920

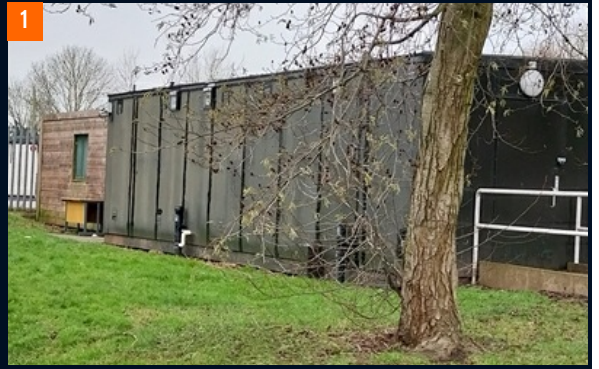
A community Junior football team were using a modified container as their main changing and shower facility. The roof and walls were found to be letting in rain water and needed to be sealed

1. The container on first inspection
2. Showing previously failed repairs
3. Belzona repairs carried out by one of the client's contractors
4. Container walls and roof resealed with Belzona 3121
