# COOLING TOWER FAN BLADES REPAIRED AND PROTECTED

ID: 9922

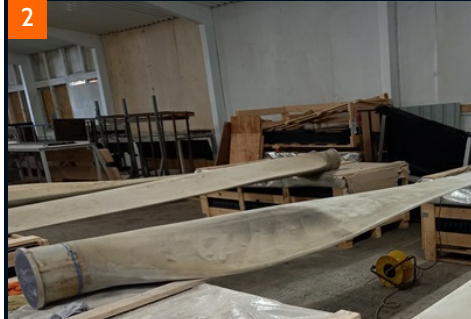
A cooling tower with 4 x 9mØ cells, each with 9 x 4.5m blades was to be refurbished, the main part of the works was to replace the blades. This was mainly due to wear and expected erosion leading to failure of the blades

36 x 4.5m x 750mm blades were to be protected using Belzona's recently released protection coating, specifically designed for Leading Edge Protection. This was the Belzona 5721

The blades were sanded to provide a key then 2 x coats of 5811 were applied to the total surfaces of the fan blades.

After curing, the 5811 was again abraded along on the leading edge, appx 80mm either side of the blade's leading edge to the length of the blade

2 coats of 5721 was then applied to complete the protective application

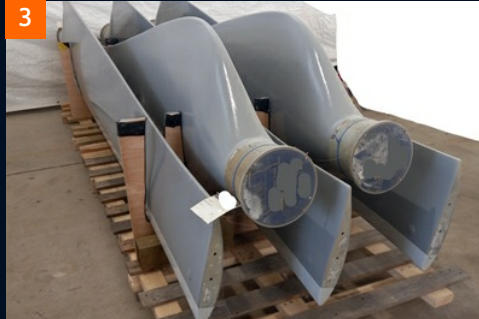
1. Training taking place
2. Blades awaiting preparation
3. Finished blades awaiting dispatch to site
4. Closer detail of finished LEP and full body protection coating
