# INTERNAL REHABILITATION OF HEAT EXCHANGER USING BELZONA 1111 & 1321

ID: 9923

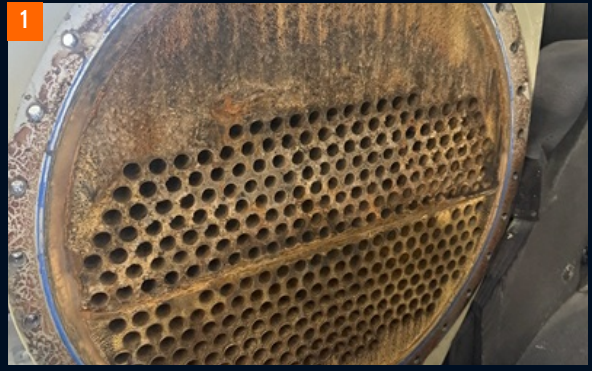
1. Initial condition of the heat exchanger showing severe corrosion and rust accumulation on the tube sheet surface.
2. Surface after abrasive blasting, showing a clean and profiled tube sheet ready for application. Tubes protected using corks.
3. Rebuilding damaged areas using Belzona 1111 (Super Metal) to restore metal loss and ensure structural integrity.
4. Completed application of Belzona 1321 in two coats with plugs removed, revealing a smooth and fully protected tube sheet surface.
