# TANK REPAIR COMPOSITE WRAP

ID: 9925

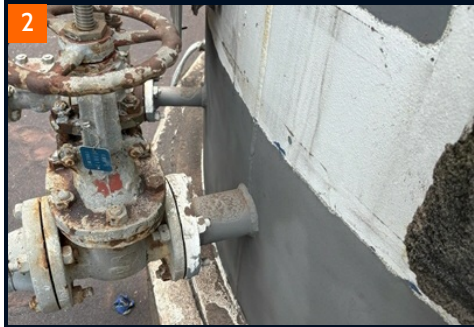
Customer had 4 nozzles coming off a tank that experienced corrosion under insulation. The metal on the nozzles were severely pitted and thin. The nozzles were close to hole through if no action was taken to prevent corrosion. The tank contents are flammable, so hot work would create unwanted downtime.

1. Insulation removed and can see the pitting / external corrosion on the nozzles
2. Abrasive blast completed per SSPC-SP10
3. Belzona 1511 was applied to smooth welds, pit fill and rebuild lost metal to help with composite wrap.
4. All four nozzles with composite wrap completed.

1. Abrasive blast the application area SSPC-SP10
2. Pit fill and smooth welds with Belzona 1511
3. Composite wrap each nozzle with Belzona 1982/9381 SuperWrap 2 for a 2 wrap/4 layer system. The nozzles were spiral wrapped and composite was flared out onto shell of the tank 10" in all directions.
4. Belzona 5111 was applied as a top coat over the repair
