# WORN SHAFT GETS THE BELZONA FORMER TREATMENT

ID: 9926

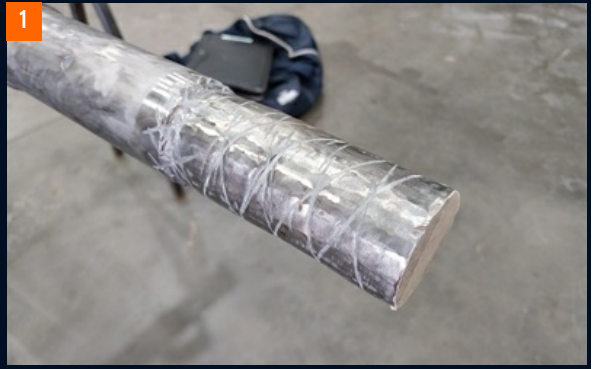
A misaligned bearing on a shaft caused excessive wear and damaged the shaft beyond normal working limits

1. Damaged shaft, prepared using a grinder/cutting disc, then degreased and cleaned using Belzona 9111
2. After wetting out the former and prepared shaft, the Belzona 1111 was applied using an applicator
3. The former was put into place and the bolts tightened to extrude the excess Belzona and leave no air entrapment
4. A rare opportunity to see the repair some months on, still showing perfect working geometry whilst now fitted into the machine

Shaft abraded with grinder/cutting disc  
Belzona 9111 used to clean and degrease  
Belzona 9411 release agent applied to former and parts of shaft adjacent to target area  
Former and shaft "wetted" out with Belzona 1111 using a short bristled brush  
Belzona 1111 applied to shaft using applicator  
Former located onto the shaft and tightened  
Allow for curing  
Remove former and dress using fine emery paper
