# BELZONA REPAIRS HOSPITAL SHOWER

ID: 9927

Patient rooms shower floors leaking

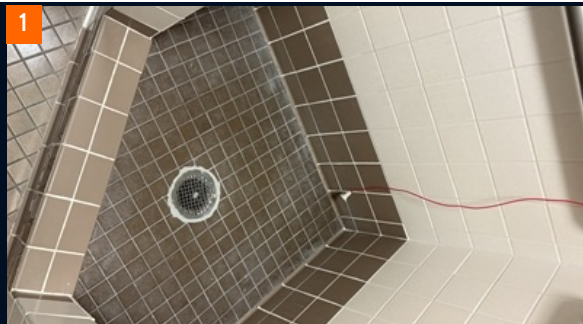
Patient shower floor was leaking when showers were being used. This was causing ceiling tile to be wet on the floor beneath and causing bacteria and having to close patient rooms. Belzona was as ample to do two rooms and release them back in 24 hours.

1. Shower floor before
2. Shower floor during surface preparation
3. Shower floor after completion
