# BELZONA ROOF APPLICATION STILL WATERTIGHT 20 YEARS ON

ID: 993

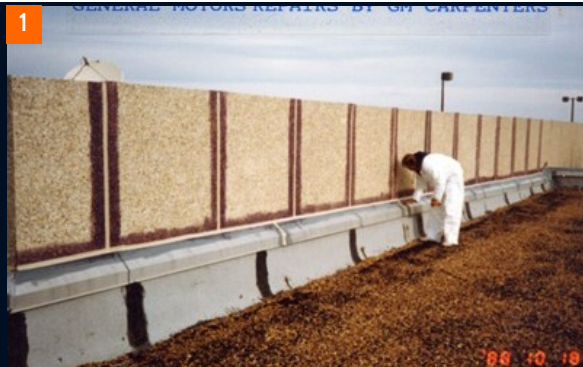
Parapet wall joints on visitors center leaking. Previous attempts with silicone sealant failed quickly.

1. Belzona 3911 being applied
2. Belzona 3111 application
3. Follow up picture February 2008

Application carried out in accordance with the Belzona Know-How System Leaflet RPA-10.

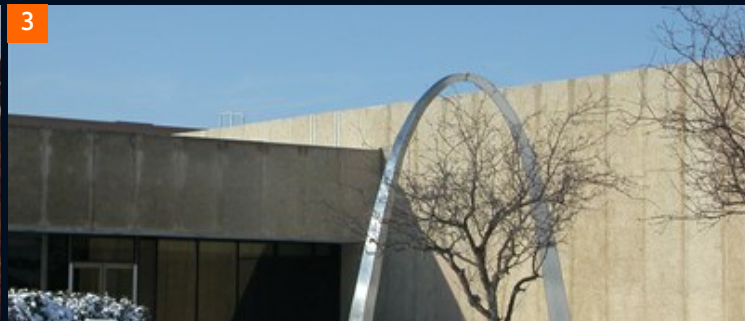
Labor costs of applying silicone sealant, which did not work, far exceeded the cost of the Belzona application. 20 years later, no leaks!
