# BELZONA REPAIRS PILLOW BLOCK ON MARINE WINCH

ID: 9930

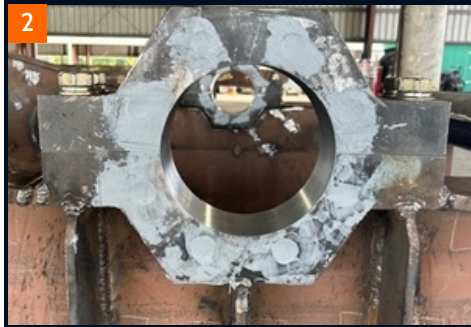
Customer had bored 1-1/2" holes when 5/8" was needed for bearing housing.

1. Pillow block with oversized bolt holes.
2. Holes filled with Belzona 1161 by injection.
3. Holes bored to correct size through the Belzona 1161.
4. Bearing casing fit-tested for installation.
