# BELZONA ELASTOMERS SAVE THE DAY ON THIS CRANE TRACK REPAIR

ID: 9931

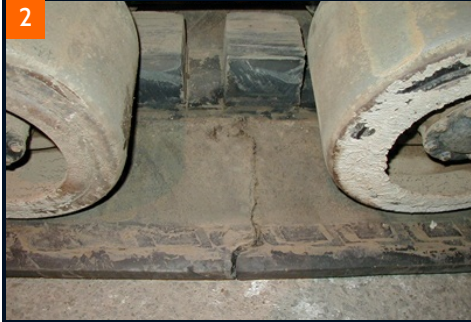
The rubber track for this crane was almost cut in half

1. Crane
2. Close up of the damaged rubber track of a crane
3. A grinder was used to prepare the substrate. Belzona 2911 (QD Conditioner) was applied to the prepared area.
4. The area was built up with Belzona 2211 (MP Hi-Build Elastomer).

A grinder was used to prepare the substrate. Belzona 2911 (QD Conditioner) was applied to the prepared area followed by a skim coat of Belzona 2221 (MP Fluid Elastomer). The area was then built up with Belzona 2211 (MP Hi-Build Elastomer). This was returned to service the following day.
