# VALVE BODY ASSEMBLY PROTECTED WITH BELZONA

ID: 9935

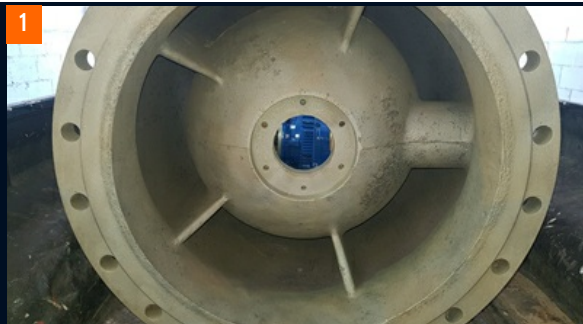
The valve assembly had damage on it from erosion of years of use in the water industry. Most of the machine surfaces had to be repaired using Belzona.

1. Valve body assembly arriving for preparation and application
2. First coat of Belzona 1321 being applied
3. Second coat of Belzona 1321 being applied
4. Valve body assembly done

The internal surfaces were abrasive blasted to obtain a clean and rough surface with an anchor profile of approximately 3 mils. A chloride contamination test was performed after blasting to confirm surface suitability. Degreasing was then carried out using Belzona 9111. Areas with visible metal loss or damage were rebuilt using Belzona 1111 (Super Metal). After the rebuilding process, Belzona 1321 (Ceramic S-Metal) was applied in two coats, grey followed by blue, to ensure full coverage and long-term corrosion. protecon.
