# EXCAVATOR EXTERNAL FUEL TANK

ID: 9936

## PROBLEM

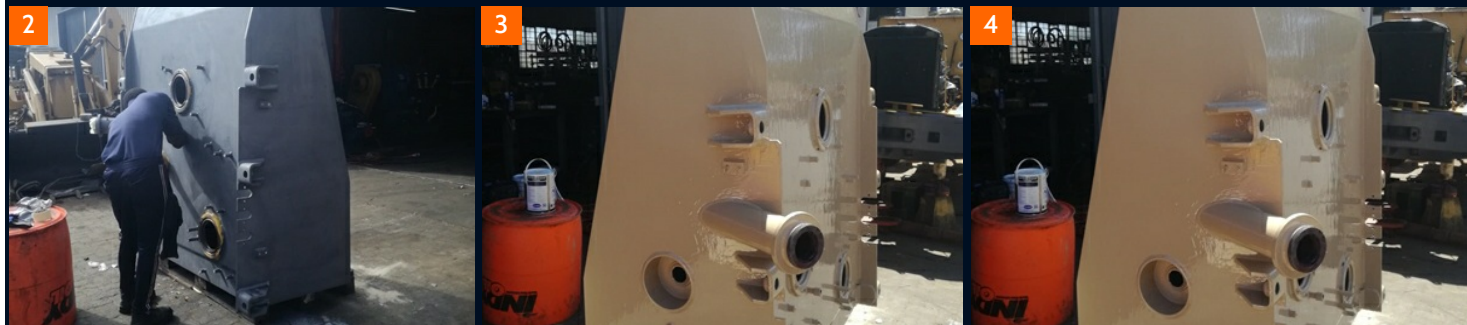
Excavator external fuel tank had rust and pitting on the outside of the tank from years of work in the mining industry. It was painted for years but it was still rusting.

1. Tank prior to application
2. First coat with Belzona 5811
3. Second coat with Belzona 5811
4. Finished application

The outside surfaces were abrasive blasted to obtain a clean and rough surface with an anchor profile of approximately 3 mils. A chloride contamination test was performed after blasting to confirm surface suitability. Degreasing was then carried out using Belzona 9111. Belzona 5811 was, then, utilized to provide corrosion protection.

Removed all paint, tar, or any other applied coating, loose surface material, grease, oil, dust, and laitance. Degreased the area, then prepared it via abrasive blasting. Applied Belzona 5811 directly on to the prepared surface with a short-bristled brush. As soon as possible, the second coat of Belzona 5811 was applied.
