# OVERHEAD REPAIRS TO SPALLED BALCONIES

ID: 9939

## PROBLEM

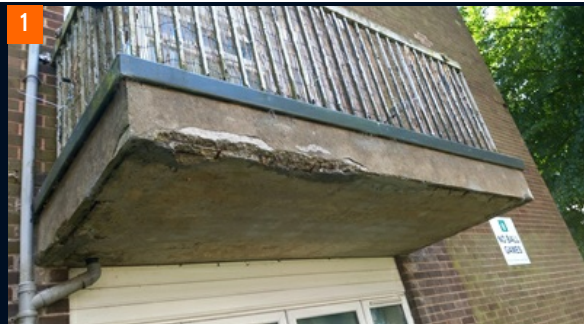
A number of balconies had started to spall and were listed as dangerous, needing urgent attention

The concrete on the balconies had started to spall and was falling from height. As a trusted supplier to the local authority, Belzona were asked to supply materials and suggest a reliable contractor to carry out the repair works. The local Belzona Engineer compiled the spec and organised the contractor, giving the authority every confidence in a job well done

1. Badly spalled concrete to under-ledge of balcony
2. Work in progress
3. 18 months on, the repairs are still in perfect condition
4. A further angle, showing 1 of 20 successful concrete repairs, some 18 months later

Break off any loose and friable faulty, spalled concrete

Wire brush all exposed repair back to clean steel
