# BELZONA FLOOR REPAIR 24 YEARS ON

ID: 994

Auto manufacturer, Wentzville, MO

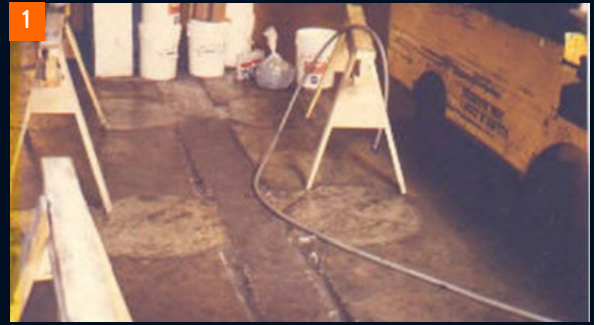
Rough area caused vehicles to lose their load, creating a safety hazard and damage to package contents. In addition, the rough ride damaged sensitive electronic equipment.

1. Original floor in 1984
2. Belzona 4111 application completed
3. Belzona 4111 in February 2008

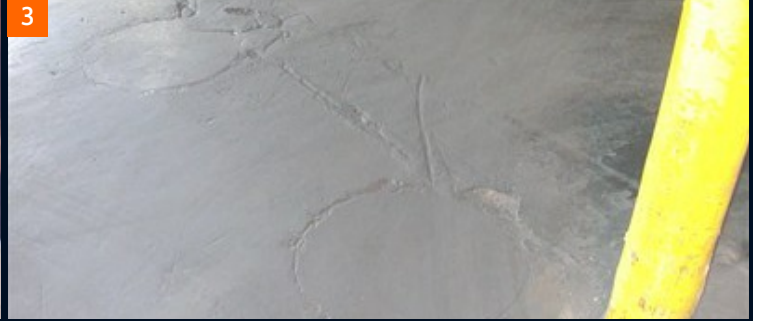
Safety concerns were paramount. One single piece of damaged electronics far surpassed the cost of the entire Belzona application. After 24 years, there is some slight damage, but the floor is still performing satisfactorily.
