# BELZONA REPAIRS UNDERFLOOR CAST CHURCH WATER PIPE

ID: 9940

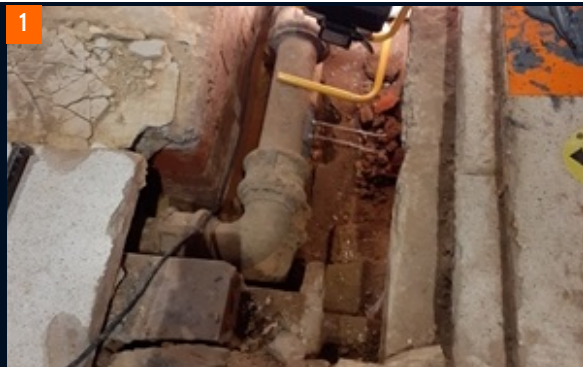
Water was accumulating on the church floor, which appeared to be emanating from under the floor itself. The floor was lifted and a large hole was identified in the cast iron mains water pipe.

1. The pipes under the floor, now isolated and the water removed. The leak was still weeping
2. The throughwall was identified as a large hole in the side of the main 4" pipe
3. As a best effort, the pipe was repaired with an oversized pre-made shell, Belzona 1212 and tie wraps
4. With the job completed, the floor boards and pews were returned to position
