# BOILER HOUSE SUMP GIVEN NEW LIFE

ID: 9941

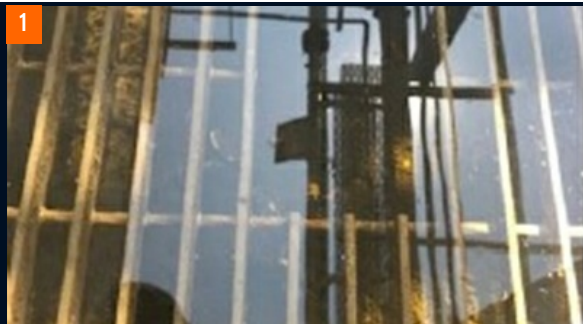
1. Sump in use, requiring emptying
2. Sump cleared and awaiting inspection
3. Prior to coating with Belzona 1391T
4. 4 years on and the Belzona 1391T has coped with submerged conditions and exceptionally difficult chemicals

Remove old coating and effect any necessary concrete repairs
