# HIGH VISIBILITY MARKING FOR FALL HAZARD

ID: 9942

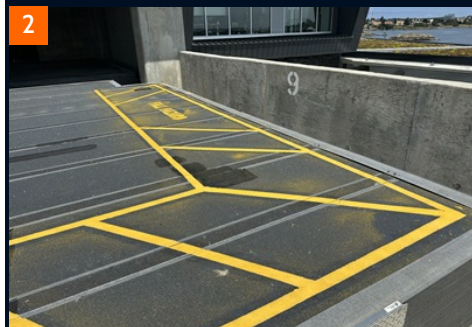
1. High visibility markings identifying fall hazard
2. Clean lines, 3 coats total were applied
3. Text application using custom stencil
4. A total 7 tank lids were completed

The areas were masked off in neat and tidy lines and a template was made indicating 'FALL HAZARD' as specified by the safety teams. Belzona 5231 was applied by brush and roller and Belzona 9231 Surefoot Aggregate was broadcasted to rejection. A final coat of Belzona 5231 was applied as a top coat.
