# BELZONA SAVES SETTLEMENT TANK ON LARGE HOLIDAY COMPLEX

ID: 9943

Leaks had appeared in the large settlement tank on the effluent plant at a large holiday complex

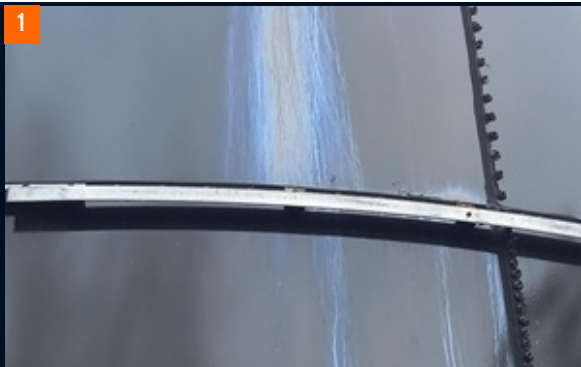
1. Leaks showing throughwall on large settlement tank
2. General throughwalls found around the tank
3. Belzona application services assessing the plan and application
4. An example of one of the repairs

Prepare substrate using 80 grit emery

Mix Belzona 1111 and wet out the target and rear side of Belzona SuperWrap II composite patch

Build up Belzona 1111 to a peak on the patch and press onto the damaged area, securing with straps, magnets or sprag

Mask up the area and apply Belzona 5831 Barrier coating to repair area
